Servicing the keels

"Taka Maru" has two cast iron lifting keels which are raised and lowered using screw jacks inside the boat. These give the boat it's ability to navigate shallow waters with the keels raised, and sail on the open seas with the keels lowered. Each keel weighs 450 kilos, and takes about 50 turns of the jack handle to raise or lower. The larger 31ft Atalantas are equipped with hydraulic jacks.

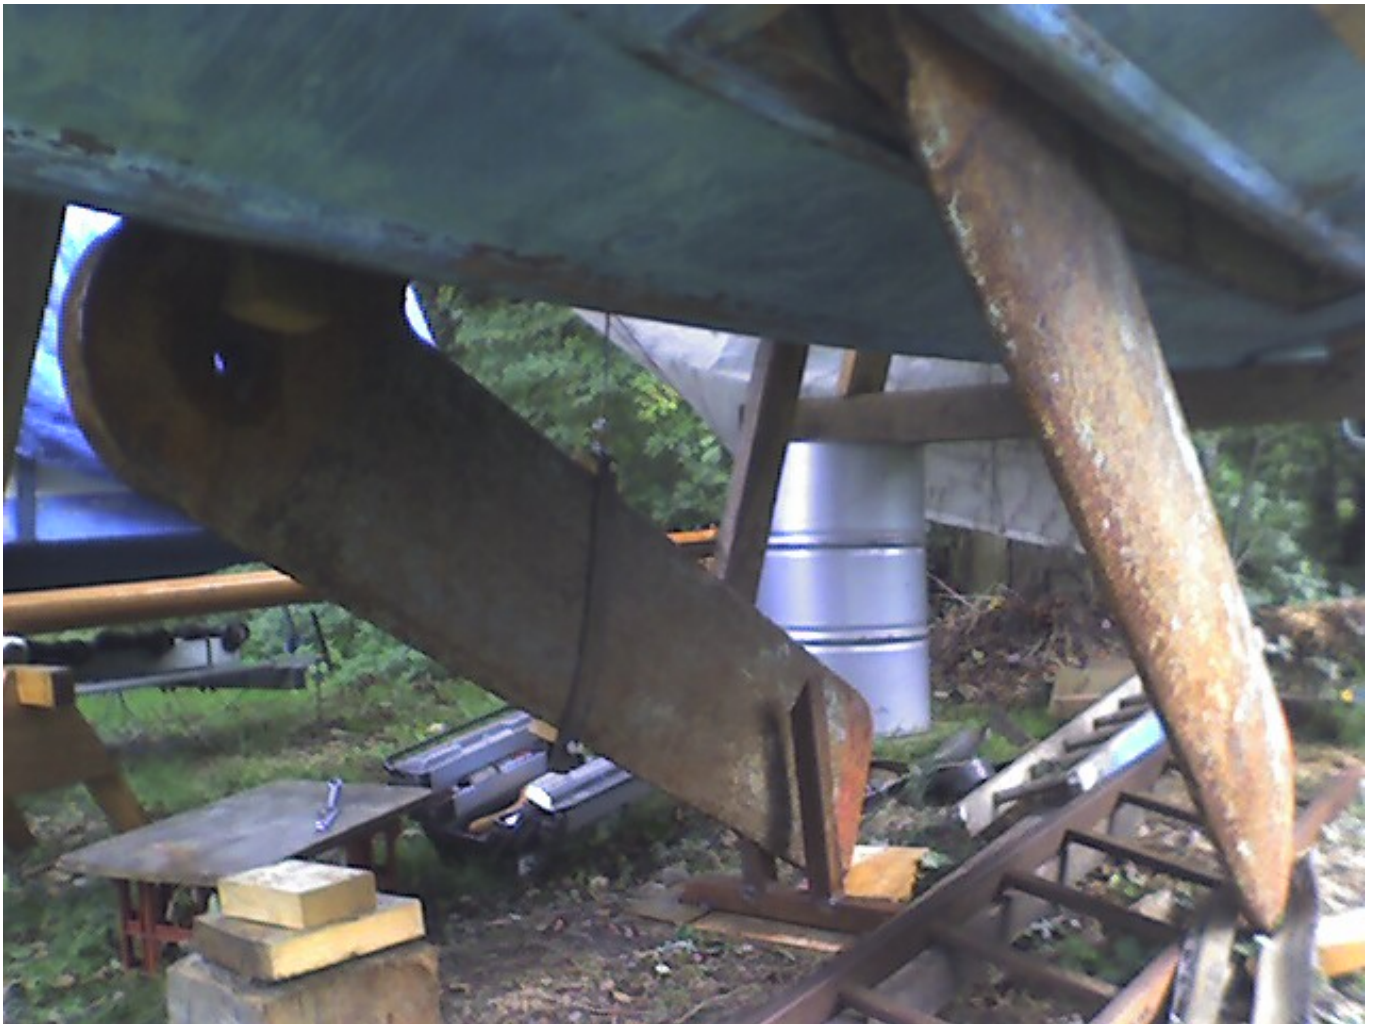
Photo: Author

In this picture the starboard keel is partly removed, and you can just make out the steel cable supporting it, and the hole through which the keel bolt fits. The port keel is in the lowered position, as it would be when the boat is sailing.

Every 5 years or so the keels need to be removed, and the metal parts which are normally under water inspected and serviced. On this occasion, the keels will be taken away to have the rust removed by grit blasting, and then plated with zinc against future corrosion. The hollow boxes in which the keels sit must also be cleaned and repainted with antifouling paint.

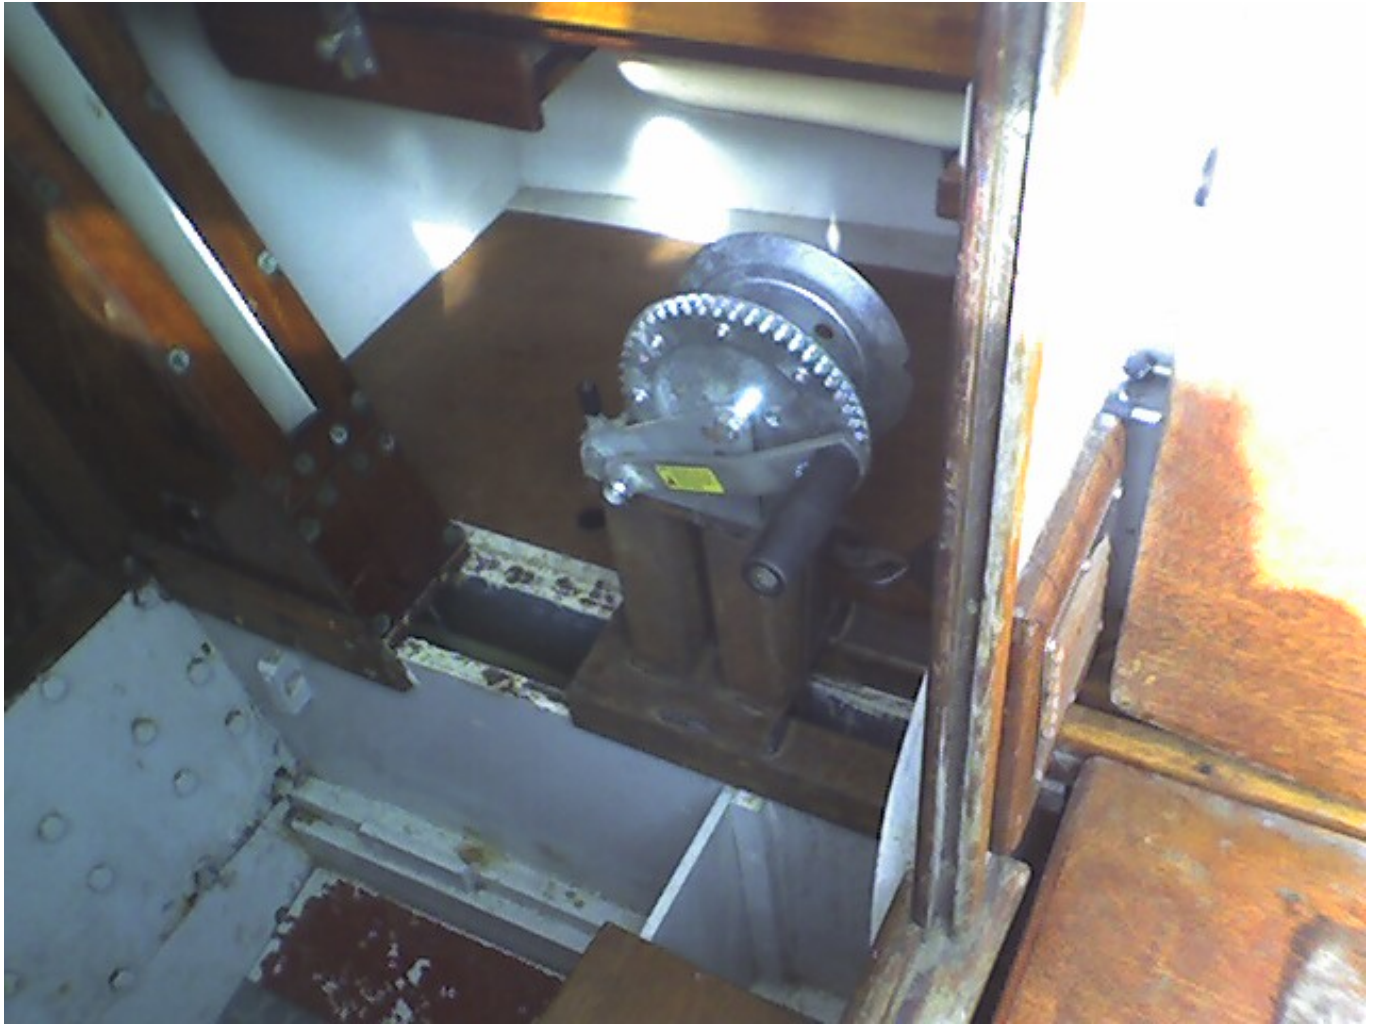
Photo: Author

Below is the winch that I'm using to lower the keels and remove them from the boat. It's made from a trailer winch bolted to welded steel "legs" so that the 5mm steel support cable passes down inside the keel box.

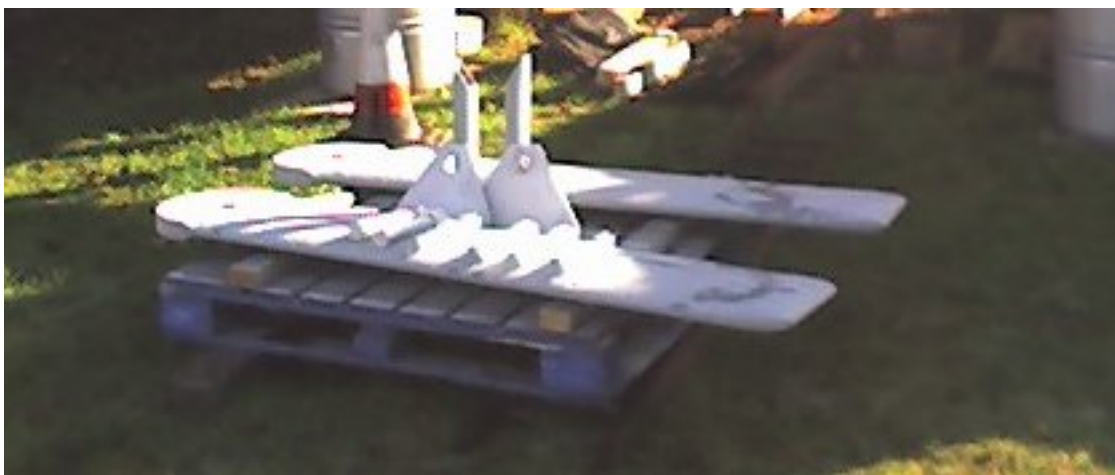
Photo: Author

Here's what the keels looked like after resurfacing:
